POWER STEERING OIL COOLER ASSEMBLY

1968-69 MONTEGO AND COUGAR
 Models Equipped with 427-4V or
 428-4V C.J. Engines Built After 6-20-68

(This article cancels and supersedes the article published in 1969 Series Service Bulletin No. 3, dated 9-30-68, same subject).

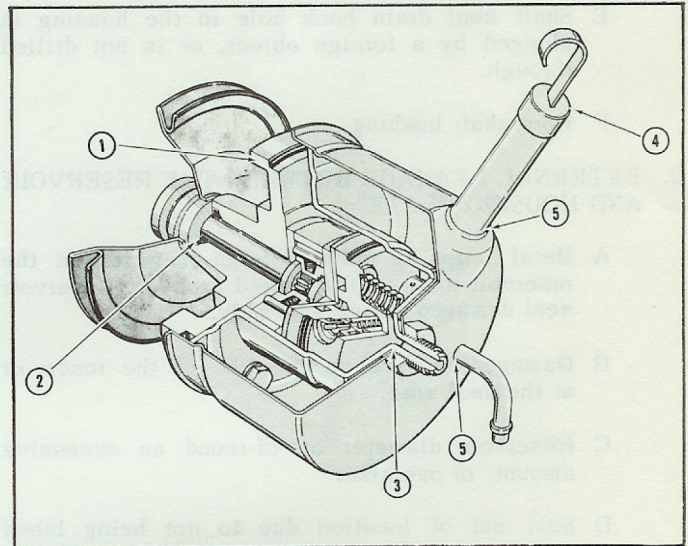
Fig. 2 – Leakage Points 9018A

There are five (5) points of possible external leakage on the Ford design power steering pump assembly (See Fig. 2).

1. Reservoir – Large Rubber Ring
2. Seal – Pump Shaft
3. Valve Outlet Fitting
4. Filler Cap – Leakage
5. Brazing and Soldering at:
 Filler Tube to Reservoir
 Return Tube to Reservoir

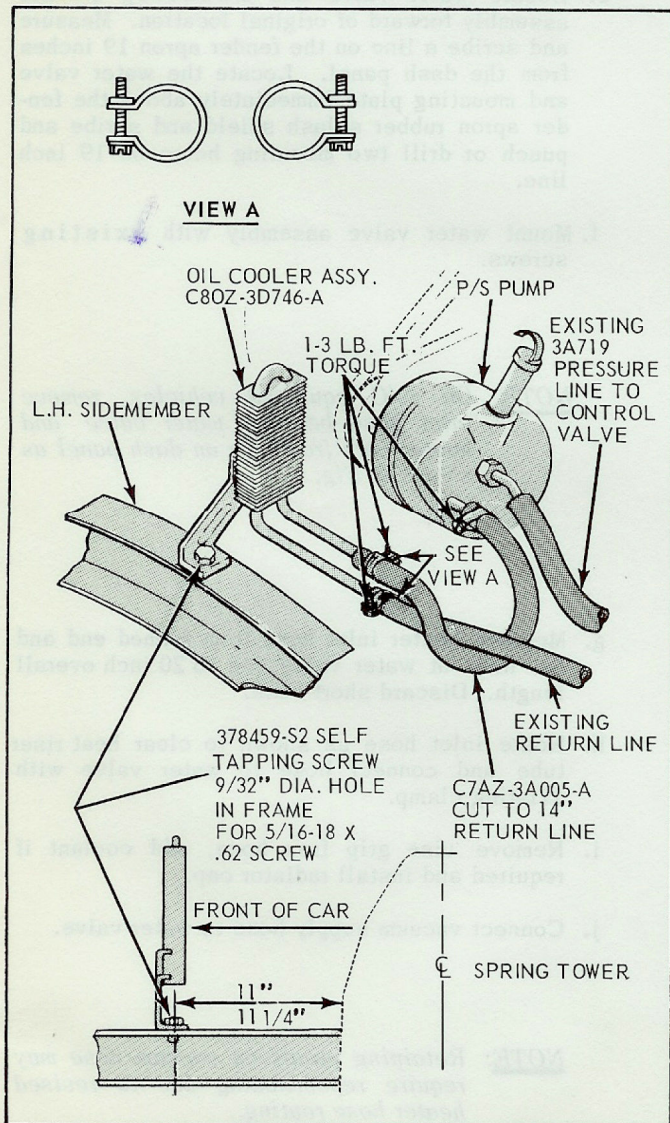
Fig. 3 - Power Steering Oil Cooler Assembly 9033A

The subject vehicles have incorporated a power steering oil cooler to provide additional fluid cooling due to the higher axle ratios and restricted cooling system used on the 427-4V and 428-4V Cobra Jet engines.

If an overheating power steering fluid condition results on subject vehicles built prior to 6-20-68, a power steering oil cooler assembly should be installed using the following installation procedure:

1. Drill one (1) 9/32" diameter hole in the left side-member forward of the spring tower as indicated in Fig. 3.
2. Install the oil cooler assembly (Part No. C80Z-3D746-A) with a self tapping screw (Part No. 378459-S2) and torque to 7-12 lb. ft. (See Fig. 3).

3. Install the existing power steering return line on the longer tube of the cooler assembly and secure with a hose clamp.
4. Install a 14" return hose (cut from Part No. C7AZ-3A005-A) to the oil cooler assembly and the power steering pump return tube. Secure with hose clamps and torque to 1-3 lb. ft.

NOTE: The clamps installed to the cooler tube must be installed with the heads facing downward. This will preclude possible chaffing of the fuel hose which is routed underneath the cooler clamps.

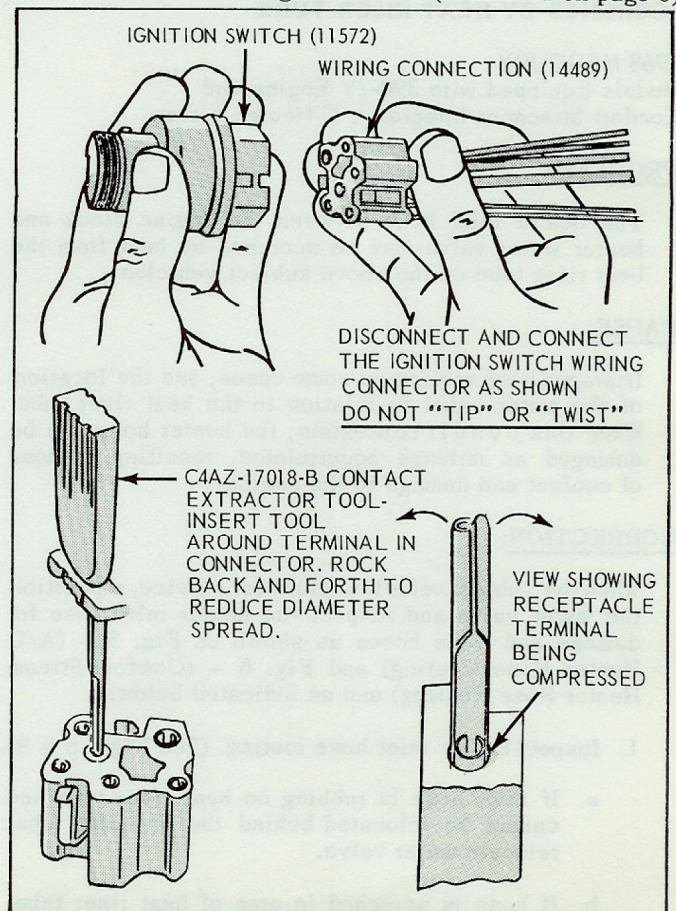
Fig. 4 - Erratic Ignition Switch Operation 9025A

Erratic ignition switch operation.

Improper installation and/or removal (tipping or twisting) of the ignition switch wiring connector. This causes the receptacle terminals within the multiple connector to spread and create a poor connection with the pin terminals.

1. Remove the ignition switch from the instrument panel. (Refer to the appropriate car line Shop Manual, Group 15).
2. Disconnect the wiring connector from the ignition switch. Do not "tip" or "twist" the wiring connector, as this can spread the receptacle terminals in the connector. The connector must be removed on a straight line from the ignition switch as illustrated on Fig. 4. (continued on page 6)
